Aging Weapons Systems Repair using Friction Stir Welding

Bryan M. Tweedy¹, William A. Arbegast², Robert H. Hrabec¹ and James M. Hutto¹

¹ H.F. Webster Engineering and Professional Services, Rapid City, SD 57702 USA

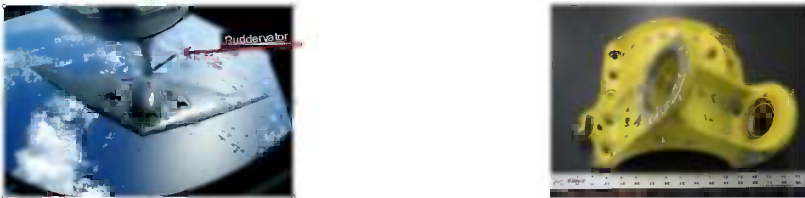
Figure 1. KC-135 Re-Fueling Boom (left) and Ruddervator Fitting (right)

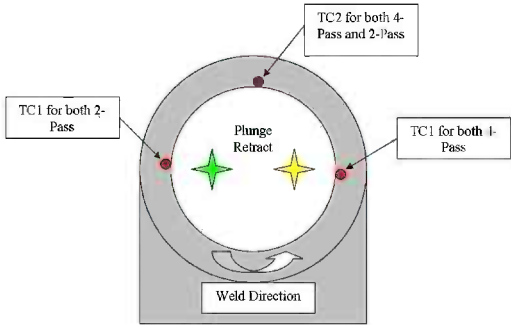
Figure 6. Thermocouple Placement Schematic

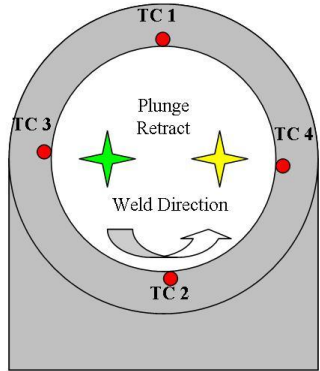
Four plugs, two large and two small, were machined from 7075-T753 bar stock. Thermocouples were mounted to the part in quadrants (Figure 13) at the base of the bearing stop and were placed with high temperature thermocouple cement.

Figure 13: Thermocouple Placement Schematic for Ruddervator Prototype Fitting
